ECOLOGICAL STATE OF LAKE DUROWSKIE ALGAE ASSESSMENT

ADAM MICKIEWICZ
UNIVERSITY
POZNAŃ

INTRODUCTION

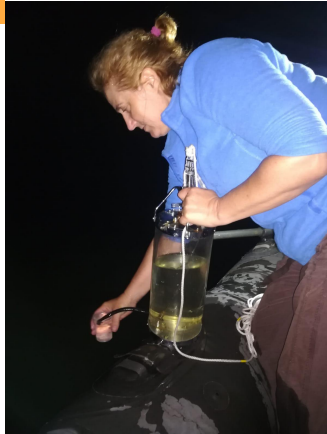
Phytoplankton
sampling sites

8 SAMPLING SITES

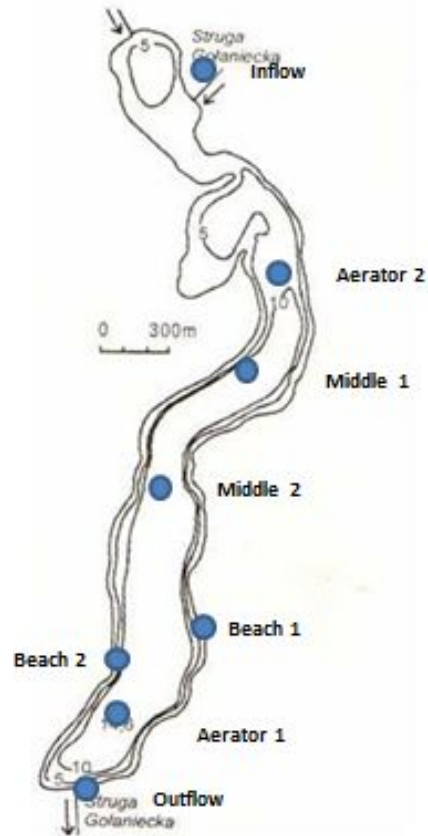
Periphyton
sampling sites

12 SAMPLING SITES

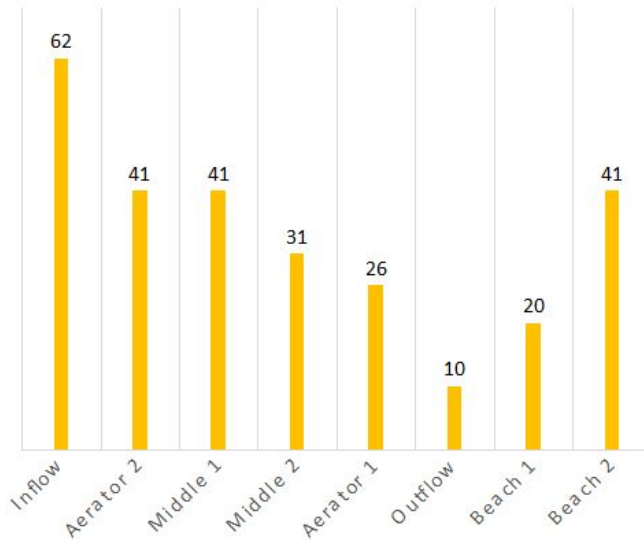
Species abundance by site (2019)

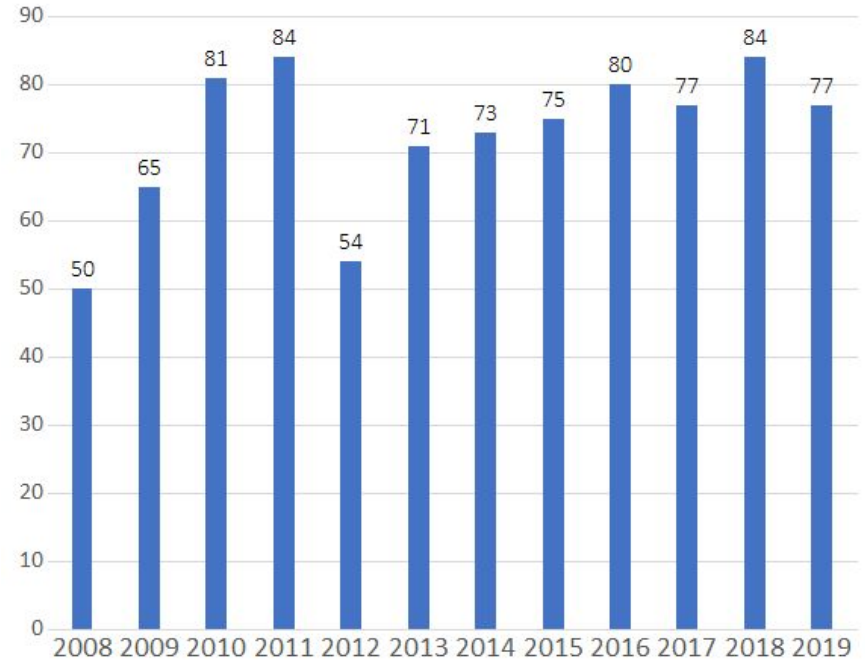
Number of species in Lake Durowskie (2008-2019)

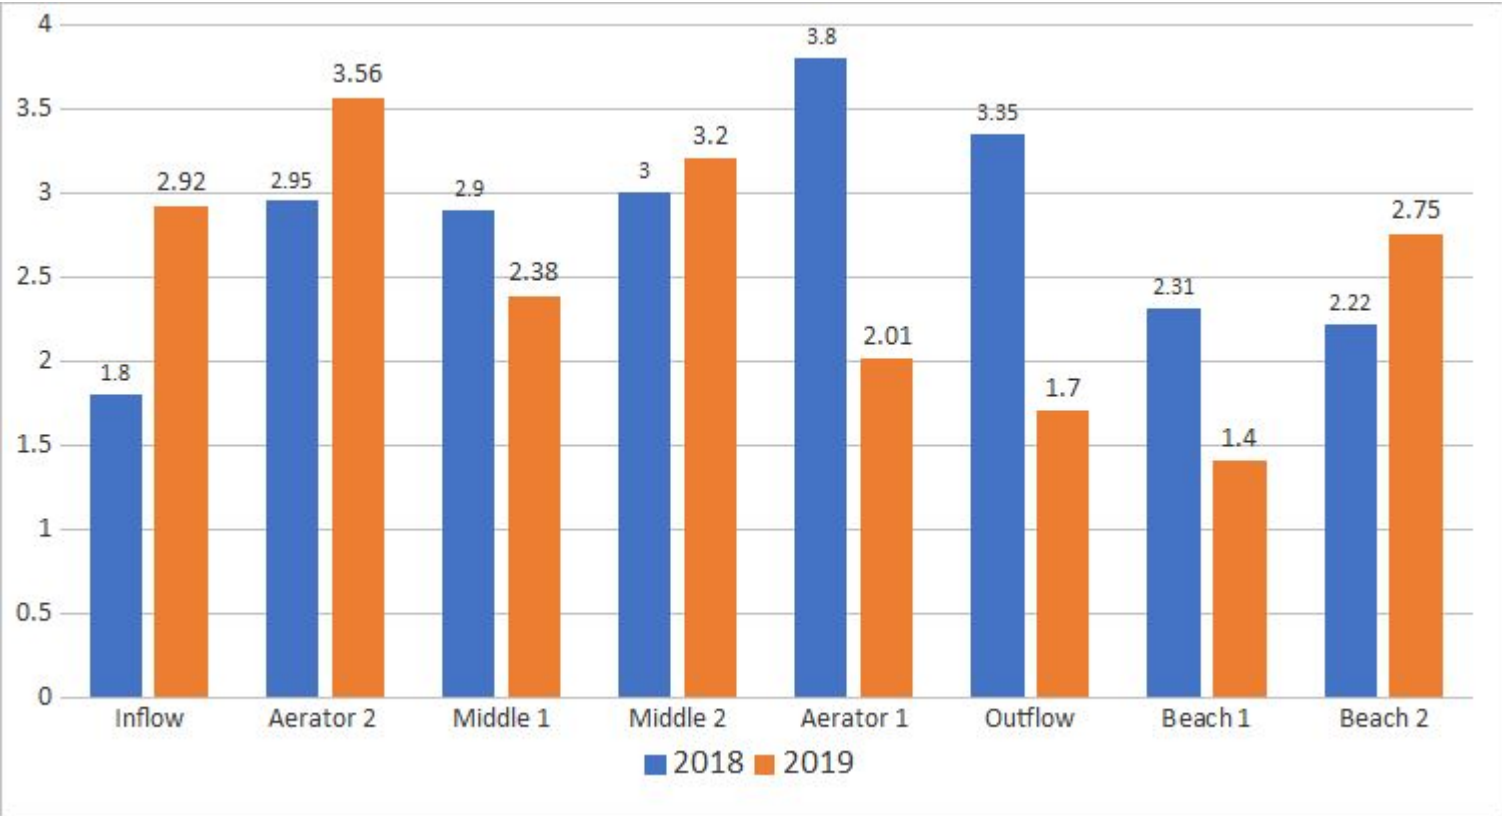
COMPARISON OF SHANNON-WEAVER INDEX IN 2018 AND 2019

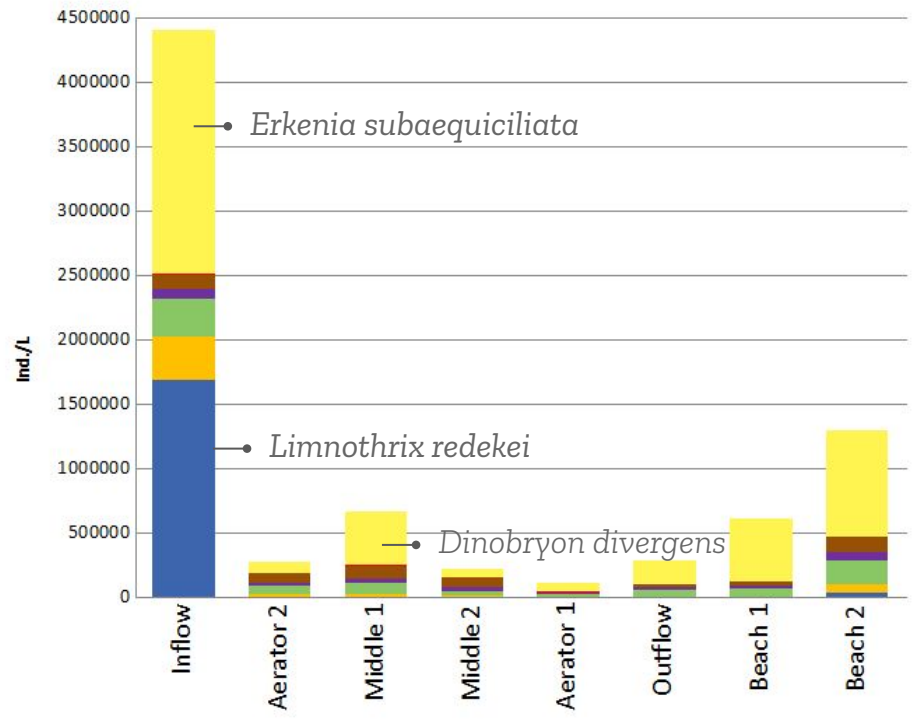
Abundance of Phytoplankton

- Stocking of predatory fishes in 2019 caused the dominance of large forms of phytoplankton: colonies and thick cell walls (they are not grazed by the zooplankton)
- The change in the species structure of phytoplankton is reflected in the improvement of the water trophy index (Nygaard composite factor).
- Despite unfavorable weather conditions, **there are no cyanobacteria** in the lake's waters, which indicates the effectiveness of restoration
- This year internal loading is clearly visible
- The middle part of the lake has a moderate water level. The northern part is in a worse condition, it is connected with the influence of the Gołaniecka Stream and anthropopressure associated with buildings

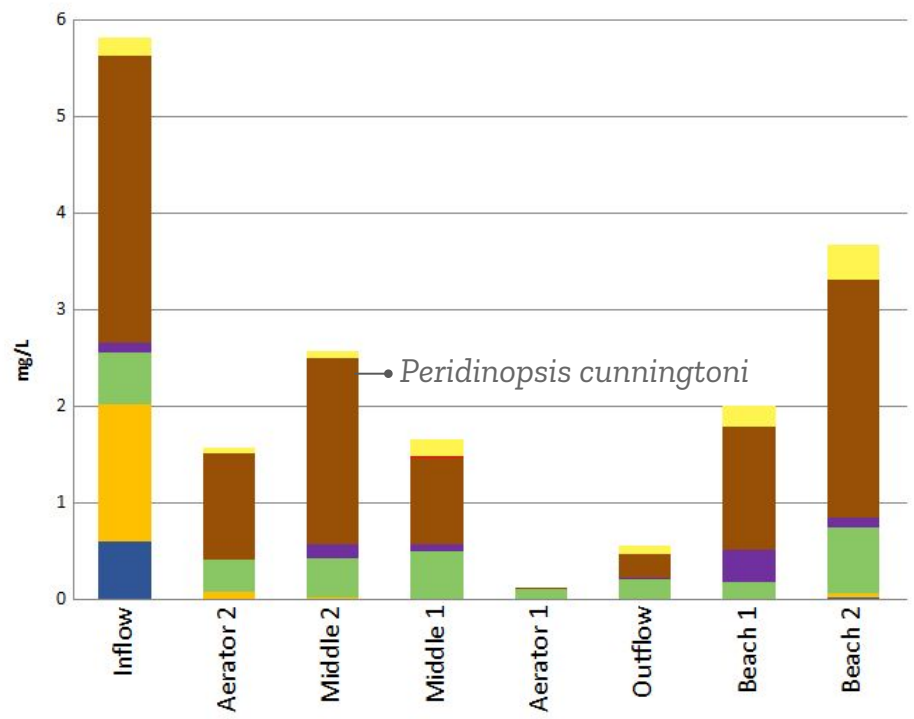
Biomass of Phytoplankton

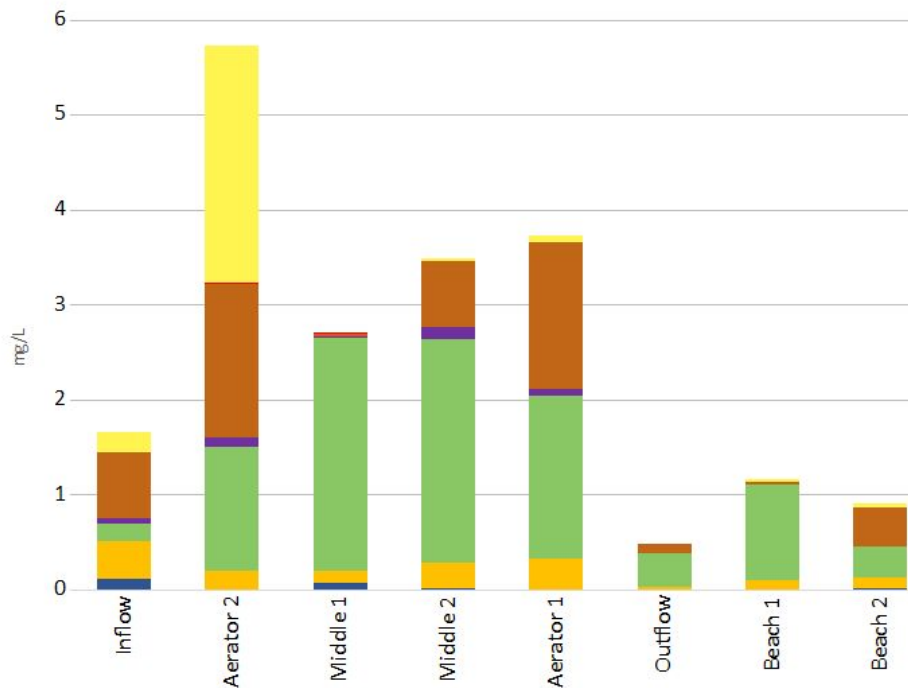
2018

COMPARISON OF PHYTOPLANKTON BIOMASS 2018/2019

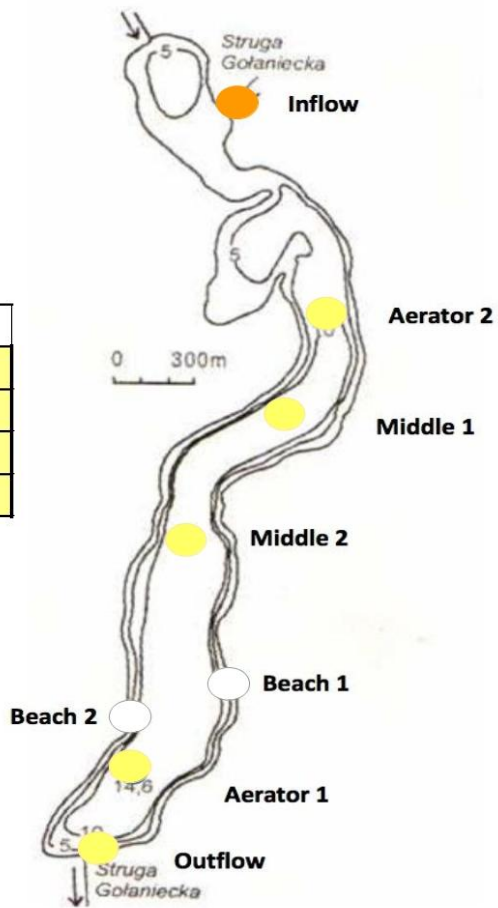
PMPL INDEX

Phytoplankton Methods for Polish Lakes

Ecological status	PMPL
Very good	0.0 – 1.0
Good	1.01 – 2.0
Moderate	2.01 – 3.0
Poor	3.01 – 4.0
Bad	4.01 – 5.0

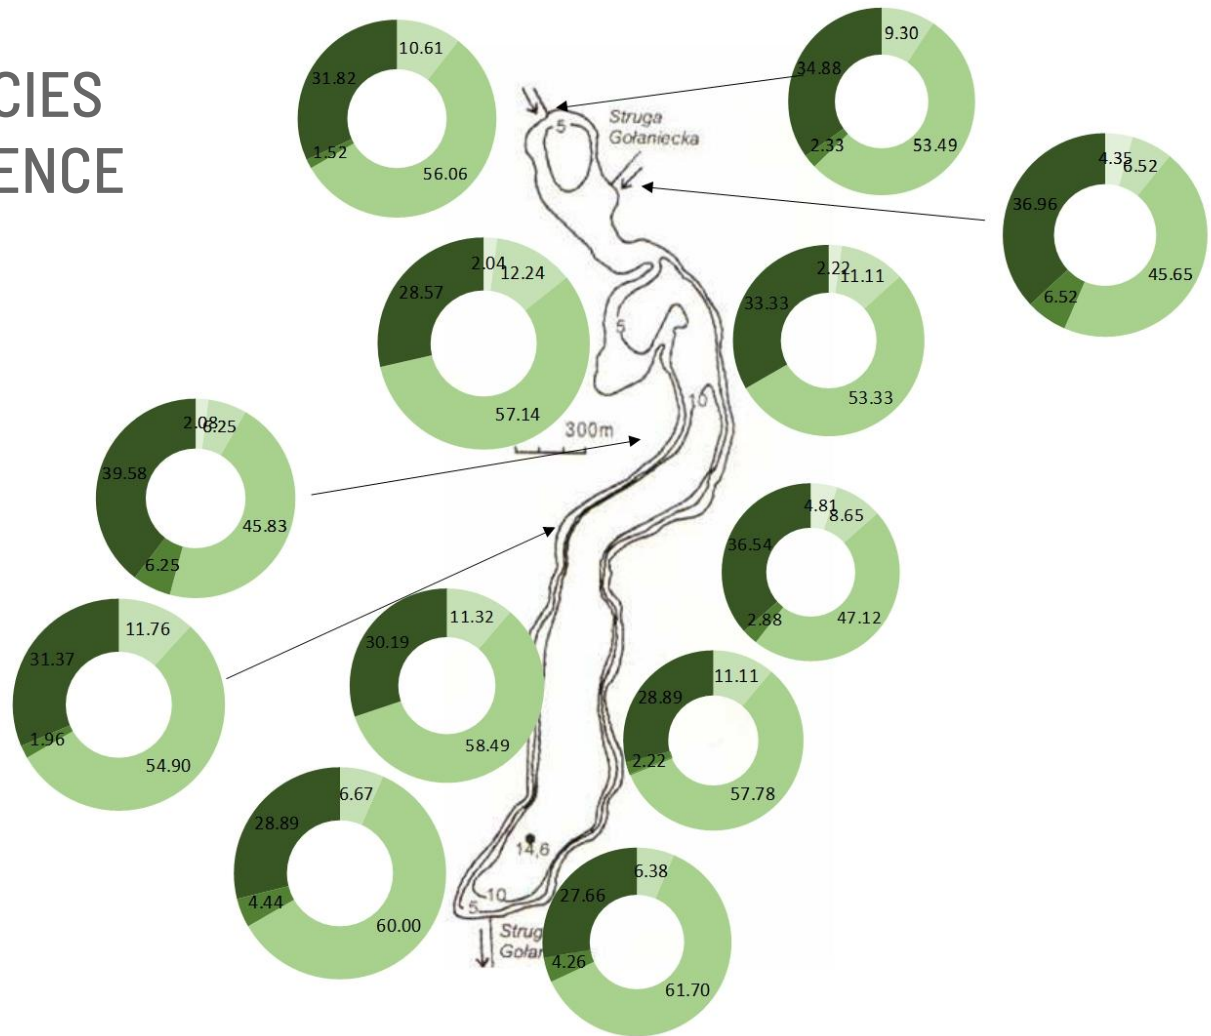
PERIPHYTON SPECIES TROPHIC PREFERENCE MAP

- Oligotrophic
- Mesotrophic
- Eutrophic
- Hypertrophic
- Others

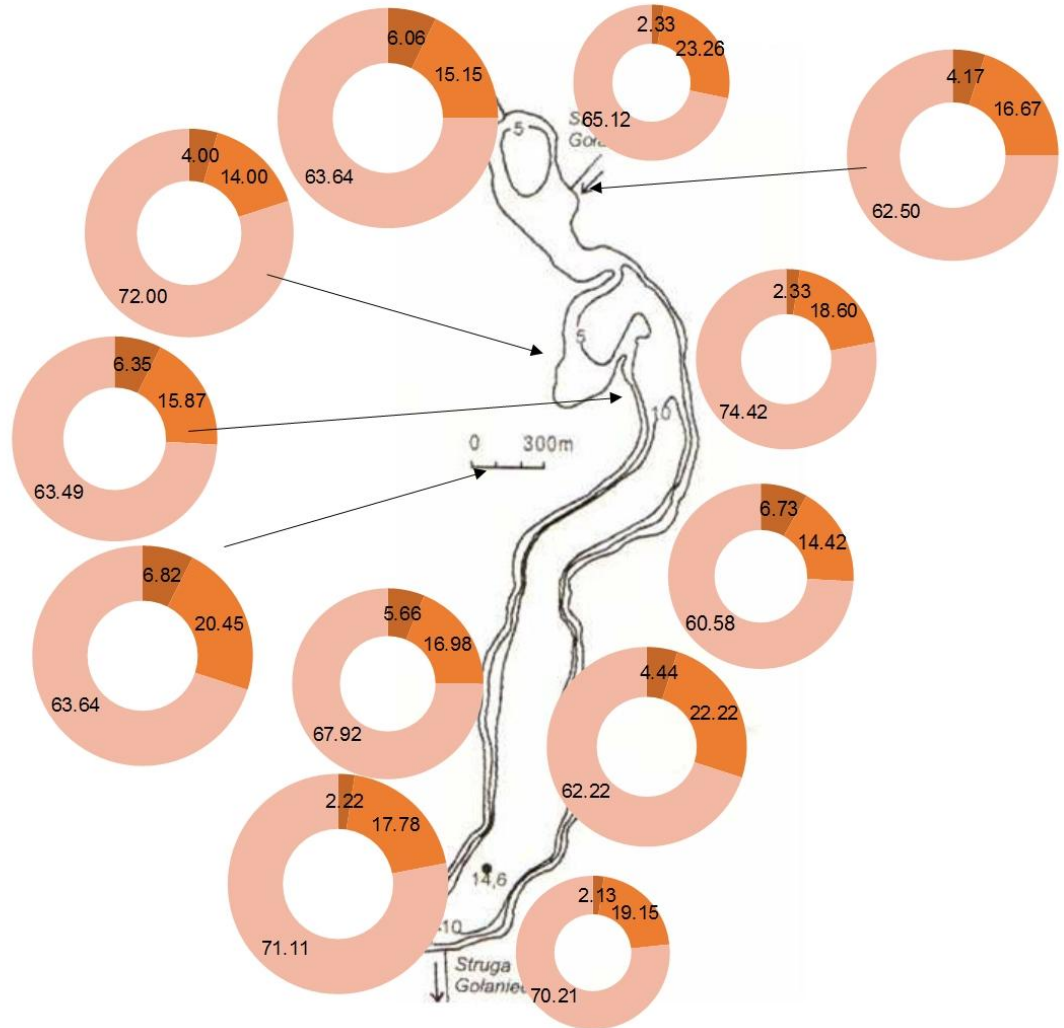
PERIPHYTON SPECIES pH PREFERENCE MAP

- Acidophilous
- Circumneutral
- Alkaliphilous

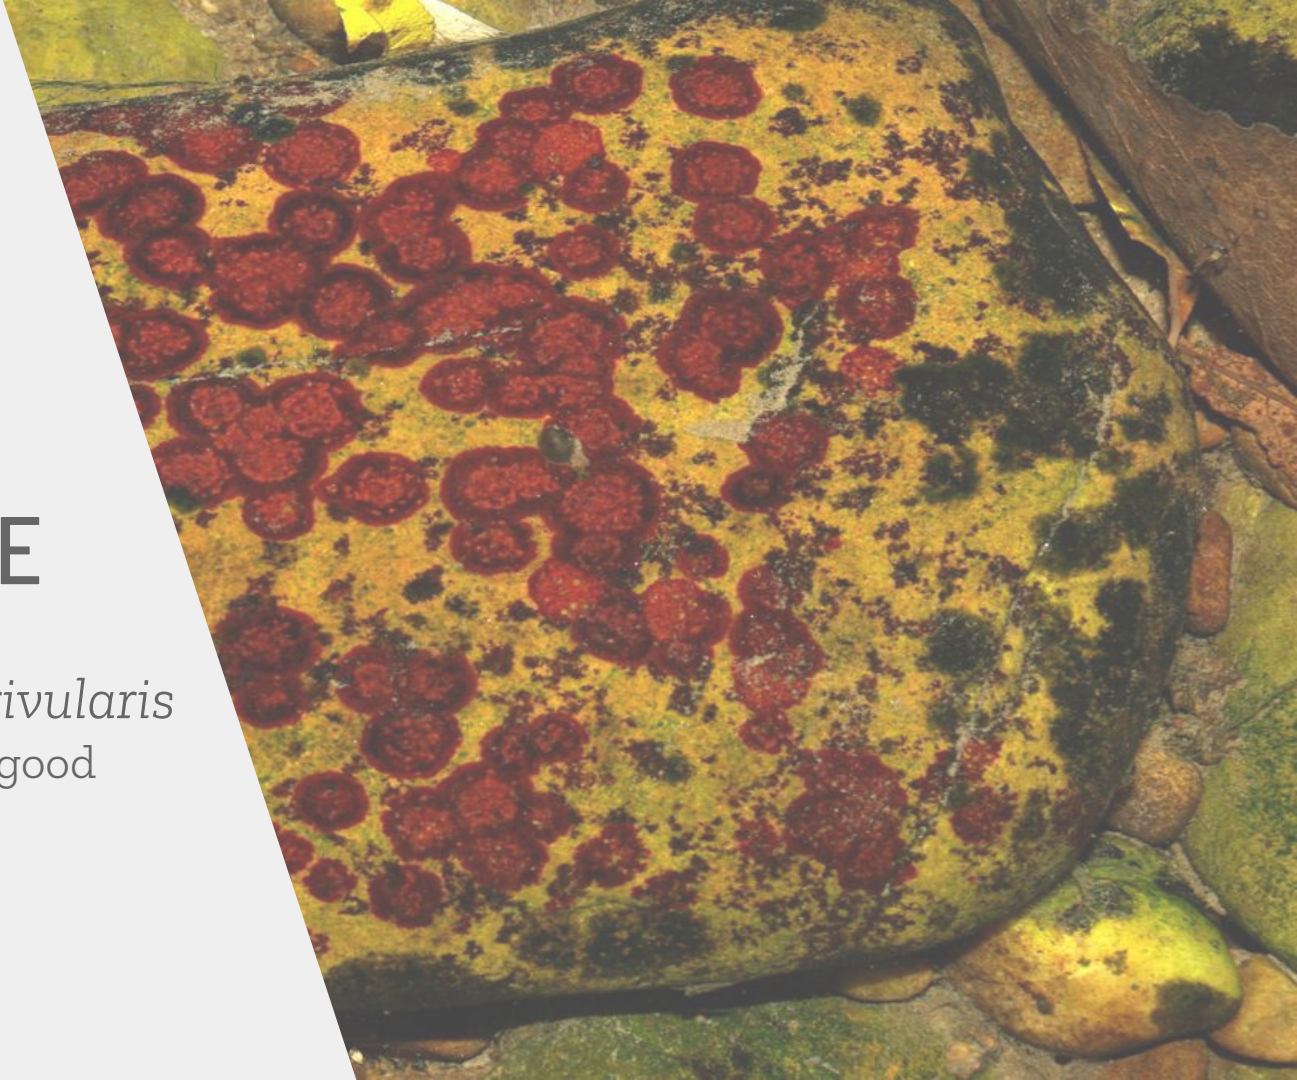
Hildenbrandia rivularis
as an indicator of good
oxygenated water

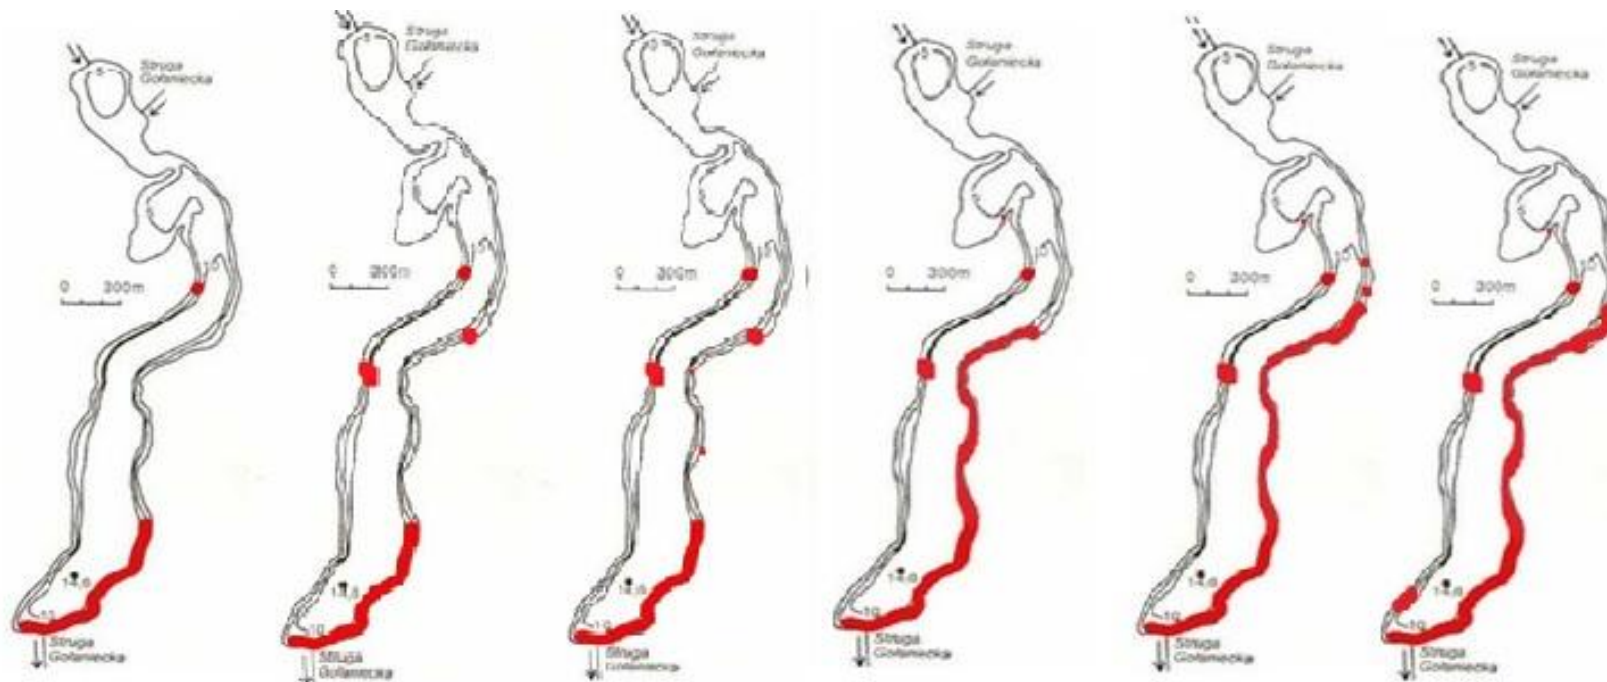
MAP OF RED ALGAE DISTRIBUTION IN 2010-2019
